## Integral Energy Sub Station - Carlingford

**Project:** Transformer Bund Areas

**Category:** Secondary Containment

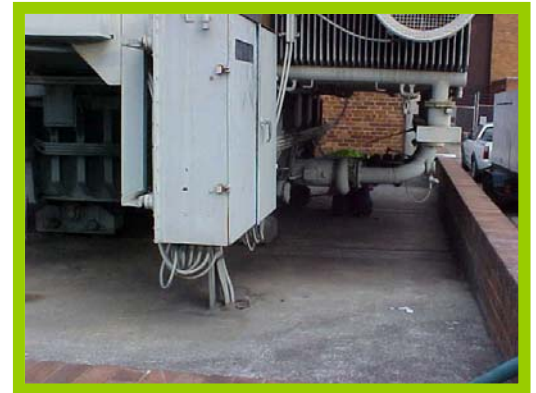
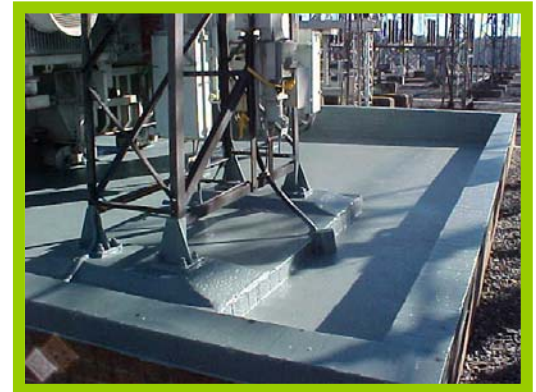
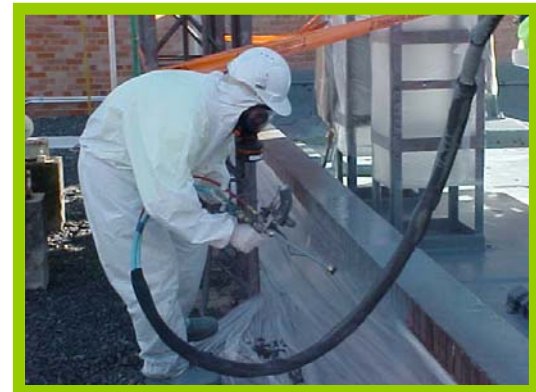
**Before...**

Four transformers at an Integral Energy Sub Station showed oil contamination problems. The transformers were leaking onto and through the concrete bund substrate.
