# Rhino Linings®

## CASE STUDY

**Project: Ore Chutes**

**Rhino Products: RhinoChem 2170**

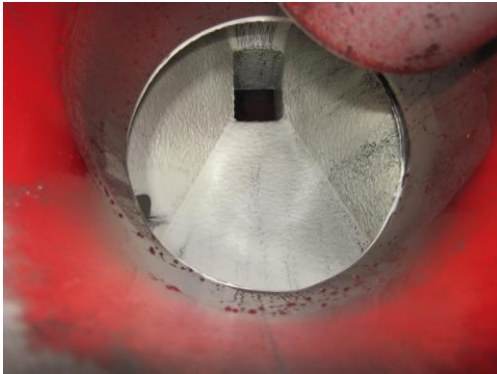
Cyclone overflow box after 12 months

This 5G densifying cyclone overflow box was coated with spray applied Rhino Linings RhinoChem 2170 for its chemical and wear resistant capabilities and was installed into service at the Argyle Diamond mine in Western Australia approximately twelve months ago.

The Maintenance Shutdown Planner for Argyle Diamonds Ltd recently checked the cyclone overflow by running a hose over it for about 5 seconds, to his satisfaction he found the part was clean, attracting no rust or ferrosilicon build up. A huge saving in replacement costs or downtime for blasting and recoating was plainly obvious from this recent examination.

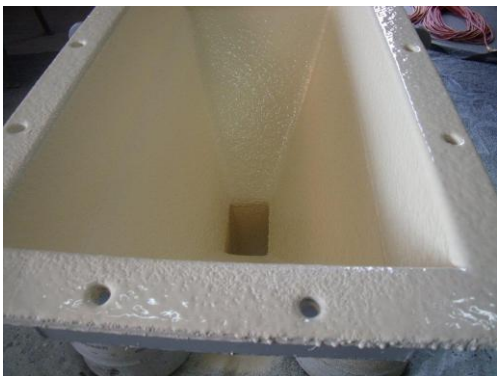
Internal coating of ore chute

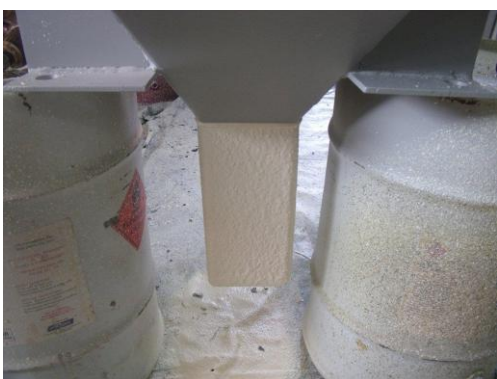
External coating of ore chute
