Project Name

Project: Caterpillar 789 Fuel Tank
Category: Impact/Corrosion resistance
Completion Date: October 2009
System: Rhino Tuff Stuff, Rhino Prime 251, Rhino Top Coat

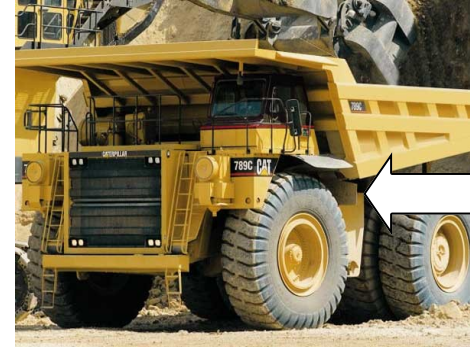
Example of a Caterpillar 789 Haul Truck Showing the position of the fuel tank

This Caterpillar 789 Haul Truck is part of a fleet used in the highly corrosive environment that exists on a mine site. As can be seen from the first photo, the fuel tank is situated directly behind the front wheel, acting as a mudguard it is therefore extremely vulnerable to impact and the client required the tank to have as much impact and corrosion resistance as possible.

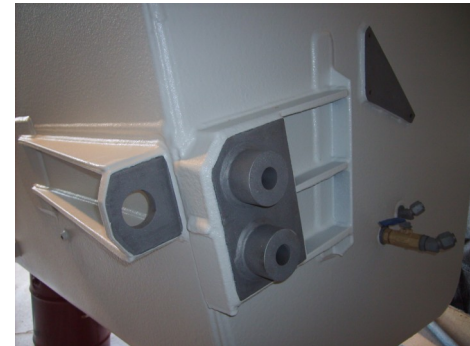
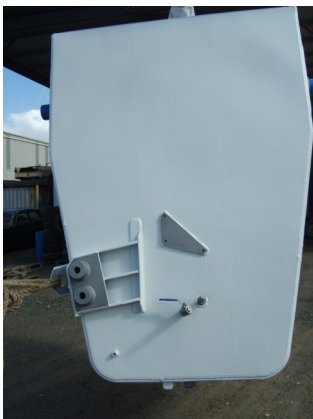
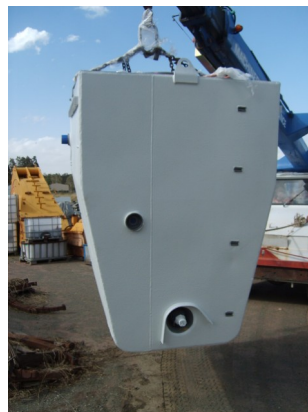
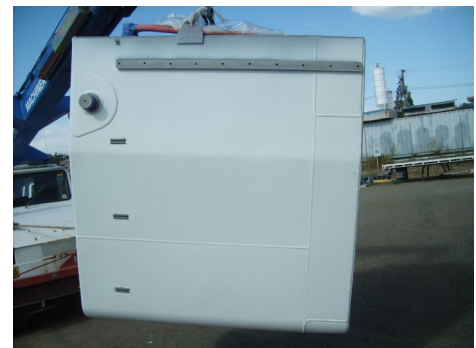
Mounting lugs were not coated due to the fine tolerances in this area.

The tank was first sandblasted and repaired prior to application of Rhino Prime 251. It was then sprayed with Rhino Tuff Stuff. The Rhino Tuff Stuff was applied to the tank at a nominal thickness of 4mm to the exterior on the lower part of the tank, reducing to a nominal thickness of 1mm then top coated in white using Rhino TopCoat.

The job was completed using a 1/4" fine texture atomizer. The extremely fast cure time of Rhino Tuff Stuff, allowed easy application to vertical and overhead surfaces.
