# Rhino Linings®

Project: Caterpillar 793 Fuel Tank  
Category: Impact/Corrosion resistance  
Completion Date: September 2010  
System: Rhino TUFF STUFF®, RhinoPrime 251, Rhino Top Coat

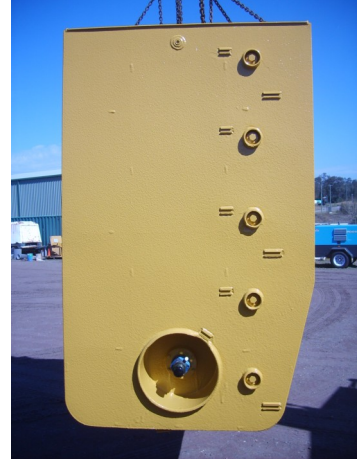
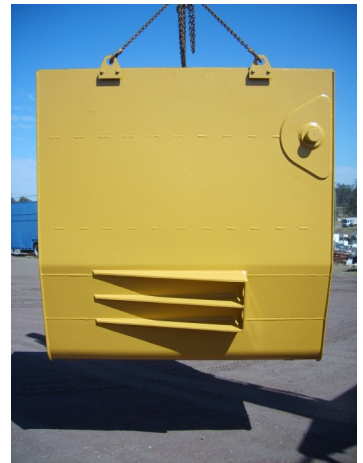
**Above and Below: The completed fuel tank after Rhino and painting Caterpillar yellow**

The tank was first suspended by a crane, sandblasted and repaired prior to application of RhinoPrime 251. It was then sprayed with Rhino TUFF STUFF®. The Rhino TUFF STUFF® was applied to the tank at a nominal thickness of 4mm to the exterior on the lower part of the tank, reducing to a nominal thickness of 1mm. The entire tank was then painted in Caterpillar yellow.

The job was completed using a 1/4" fine texture atomizer. The extremely fast cure time of Rhino TUFF STUFF®, allowed easy application to vertical and overhead surfaces.

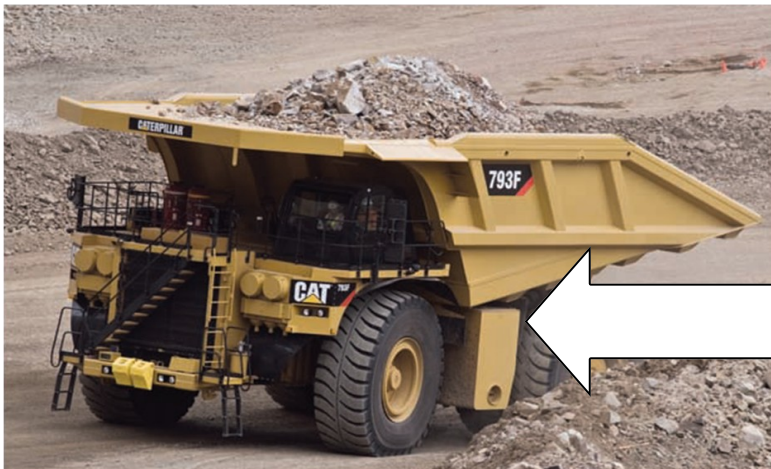
This Caterpillar 793 Haul Truck is part of a fleet used in the highly corrosive environment that exists on a mine site. As can be seen from the first photo, the 5,000 ltr fuel tank is situated directly behind the front wheel, acting as a mudguard, it is therefore extremely vulnerable to impact and the client required the tank to have as much impact and corrosion resistance as possible.

**Left: This picture of a CAT 793 shows the position of the fuel tank.**
