Project: Komatsu HD-785 Diesel and Hydraulic Storage Tanks

Category: Insulation & Corrosion Protection

Product: Rhino TUFF STUFF[®] Polyurethane

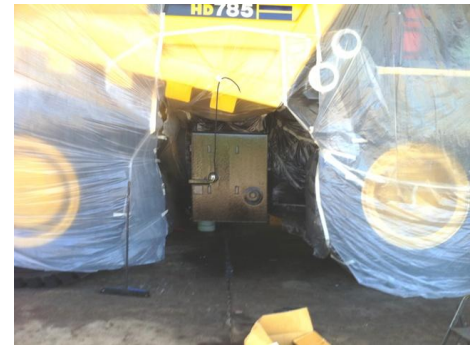
Masked Dump Truck

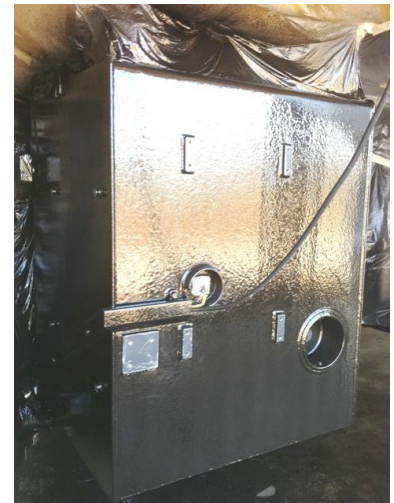
Diesel Tank Coating

In providing a solution to Komatsu's problem, Rhino Linings East Perth (Beam Rust Proofing) sprayed Rhino TUFF STUFF premium polyurethane to a nominal thickness of 4mm over the accessible areas of the two oil storage tanks (diesel and Hydraulic oil) on each HD-785 Dump Truck in the customers fleet.

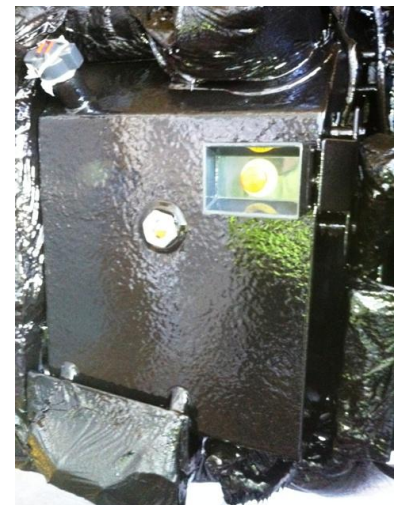
Hydraulic Tank Coating
