Live Sewer Pit – Urgent Repair

Project: Waste Water Treatment Plant

Category: Corrosion, Protection & Gas Attack

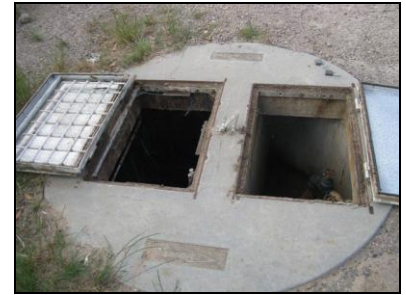
Access restrictions

The upstream main was temporarily pumped to a storage truck and the main well inlets were plugged before cleaning commenced.

With these access restrictions in mind, Adelaide Waterproofing used a 2500psi 22L/min turbo head pressure washer to clean the wet well and provide substrate profile. They then dried and tested the substrate for contaminants followed by the application of a 3 - 4mm coating of Rhino 100% Pure Polyurea.

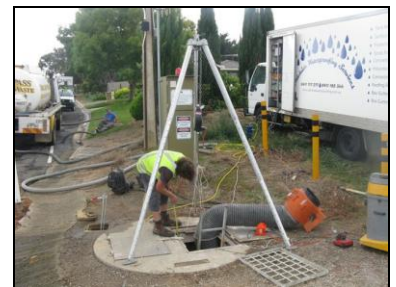
Confined space and limited access

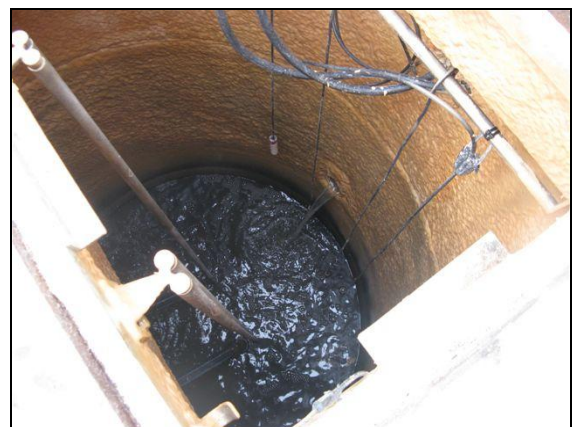
Finished live wet well

The surface finish was less important in this case (spray applied elastomers follow the substrate profile) and H₂S gas attack was positively removed with our high build Rhino Linings 100% Pure Polyurea coating.
