Project: Mine Site Truck Cab
Category: Corrosion Protection and anti slip flooring
Completed: February 2010
Products Used: Rhino Tuff Stuff, Rhino Prime 251.

Example of a Komatsu 830e Haul Truck

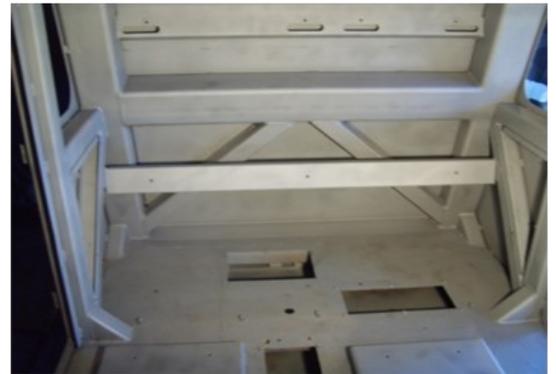
Inside rear of cab after sandblasting

The cab was first sandblasted and repaired prior to application of Rhino Prime 251. It was then sprayed with Rhino Tuff Stuff. The Rhino Tuff Stuff was applied to the cab at a nominal thickness of 2mm to the inside roof, walls and console, 4mm to the underside of the cab and to the inside of the doors and the floor. The floor also had non slip particles applied.

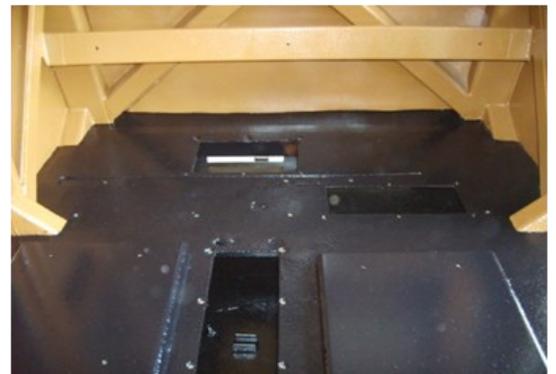
Inside rear with Rhino Tuff Stuff & Top Coat

The job was completed over a three day period using a 1/4" fine texture atomizer. The extremely fast cure time of Rhino Tuff Stuff, allowed easy application to vertical and overhead surfaces.

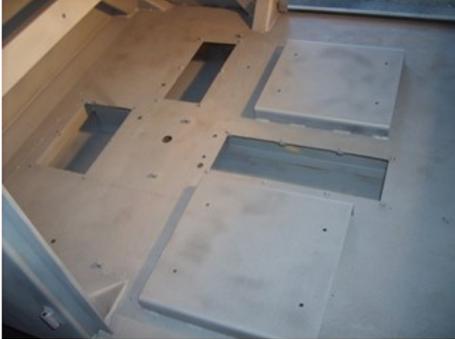
Cab after sandblasting

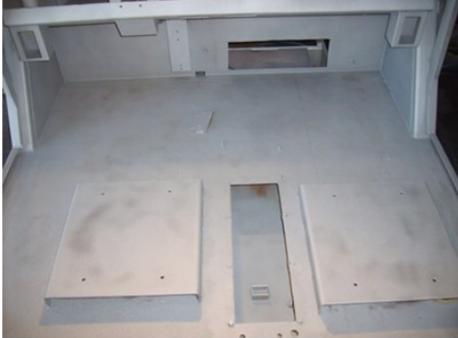
Inside front of Cab after sandblasting

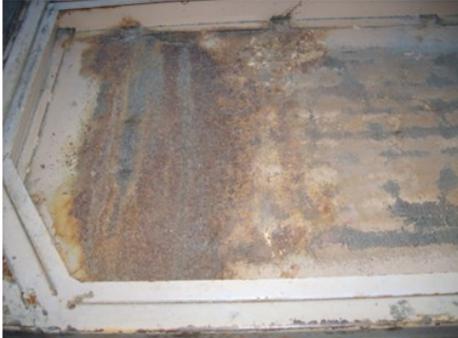
Cab door before application

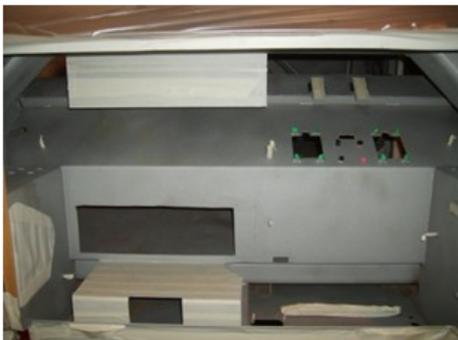
Rear of console after sandblasting

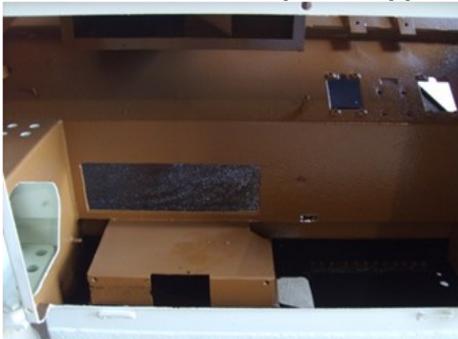
Rear console after Top Coat application

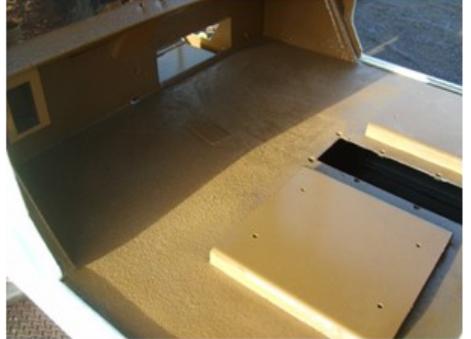
After Tuff Stuff & slip resistant

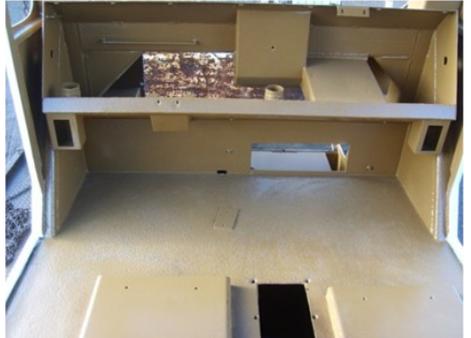
Inside front of cab & console after

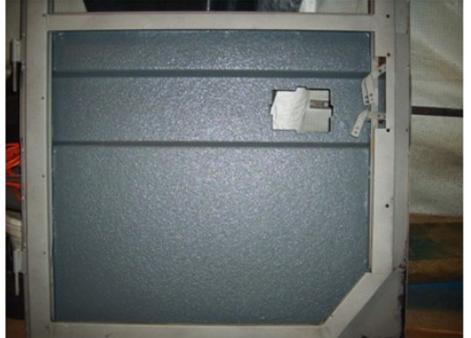
Cab door after application

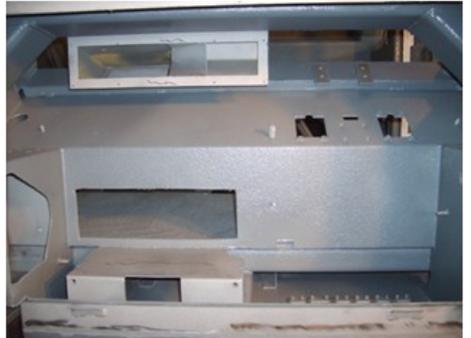
Rear console after Tuff Stuff application

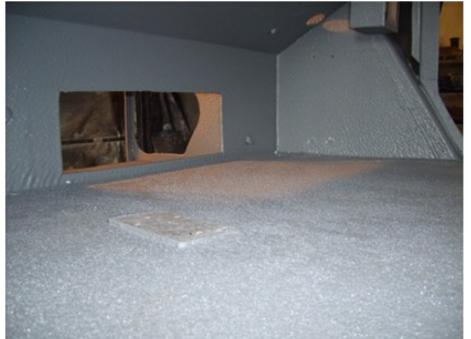
Close up of Tuff Stuff & Slip Resistant
