CASE STUDY

Water Feature

Category: Waterproofing
Project: Water Feature at Silo Park, Auckland, NZ
Applicator: Rhino Linings Central Auckland, NZ
Rhino Products: Rhino Linings Tuff Stuff®

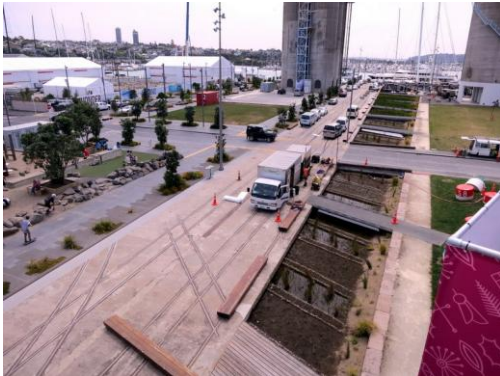
Completed work

Originally the concrete ponds at Silo Park had been lined with a HDPE (High Density Poly Ethylene) membrane which over time had failed resulting in the pond constantly losing water.

Due to the waterproofing properties, Rhino Linings Tuff Stuff® was specified for the pond rectification (Class III Wet Area Membrane). Geotextile was also used to facilitate the application of the polyurethane coating over the concrete and earthen substrate.

On completion this project was certified by Auckland City Council

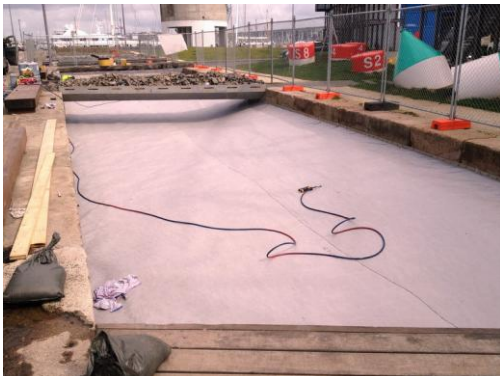
Application of geotextile

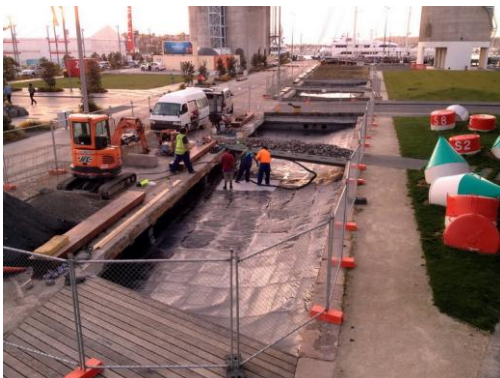
Application of Rhino Tuff Stuff
