# Rhino Linings®

## CASE STUDY

Wild West Ride – Warner Bros. Movieworld

**Category:** Waterproofing  
**Project:** Ride Attraction  
**Applicator:** Relining Services  
(Rhino Linings® Approved Applicator)

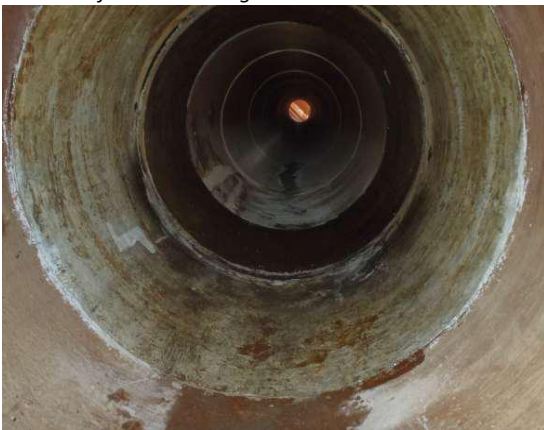
The Wild West Ride at Warner Bros. Movieworld based on the Gold Coast was reported to have a significant leak and the water level was dropping. Movieworld engineers drained the attraction and located the leak to be in the joint on a 1200mm diameter concrete pipe connecting the main attraction to the balancing tank. The rubber gasket had deteriorated and attempts made to reseal had failed.

Location of deteriorated gasket

Relining Services (Rhino Linings Approved Applicator) was contracted to remove the deteriorated gasket and apply a polyurethane water-stop. The procedure included grinding, etching and cleaning the area prior to priming with a polyurethane bonding agent. Termination grooves were cut at the edges of the Rhino Linings TUFF STUFF® spray applied membrane to ensure superior adhesion and seal the surface surrounding the gasket.

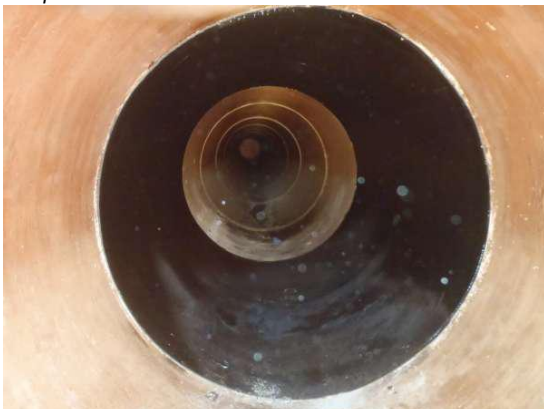
The attraction was filled again and put back into service. The water leak has significantly dropped and is currently being monitored. Engineers are looking to coat further areas throughout the attraction during the next maintenance shut down.

Completed work
