## Energy Sub Station Bund

**Project:** Integral Energy Substation

**Category:** Secondary Containment

**Product:** Rhino Linings Tuff Stuff

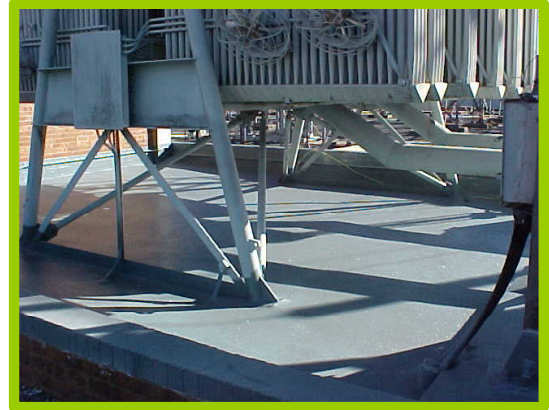
Four transformers at the Integral Energy Sub Station were experiencing oil containment problems. The transformers were leaking oil onto and through the concrete, leaching into the ground below.

After having the concrete cleaned, and the brick walls bagged, Rhino Linings Duraspray was applied to the walls and floors to form a fully contained bed area. 24 grit aggregate was also added to the traffic areas addressing OH&S requirements.
