# Rhino Linings®

## CASE STUDY

**Project:** Hospital Laundry Vehicles

**Rhino Products:** RhinoGuard 2195 Polyurethane

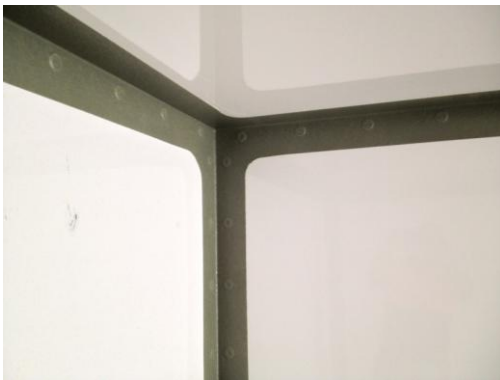
RhinoGuard 2195 spray applied Hybrid Polyurethane was specified for these hospital laundry vehicles due to the products total sealing and encapsulating capabilities.

The fibreglass ply wall corners and chequer plate floor were totally sealed at the joints and aluminium oxide grit was added to prevent slippage. This has allowed the truck to be hosed out regularly to control hygiene and provide a safe work place for the people loading the linen trolleys in what is often a wet environment.
