Lihir Gold Mine, PNG

Project: Lining of rake arms and support arm

System: Modified Polyurea MP95

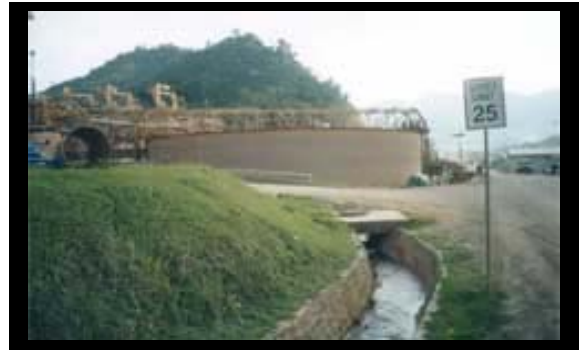
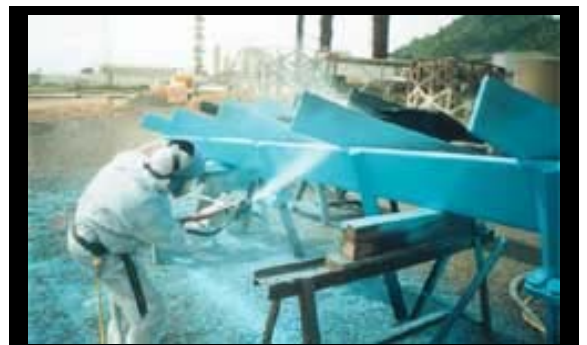
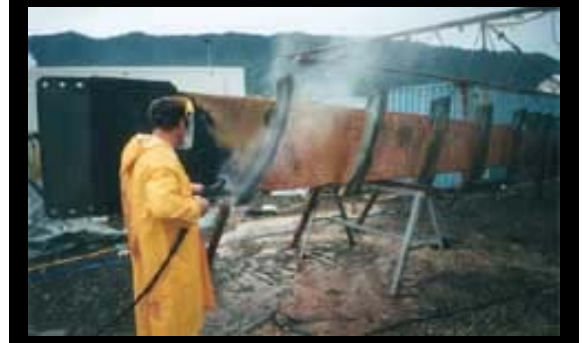
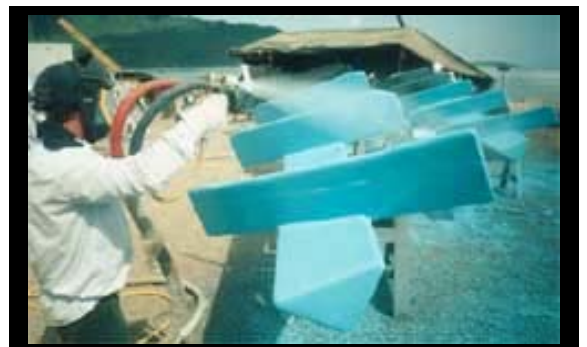
The CCD tank requiring the coating of the rake arms and support arm of the deflector cone, along with the inside of the feed well is shown in the photographs. The CCD tank operates at approximately 70°C, with a low pH, and is only available for repairs on a complete plant shutdown. The rake arms are coated to 3mm dry film thickness (DFT), with a 10mm DFT on the bottom of the rakes. The deflector cone is coated with 3mm and the support arm 10mm DFT.
