Mezzanine Floor

Project: Factory Mezzanine Floor

Category: Commercial Flooring

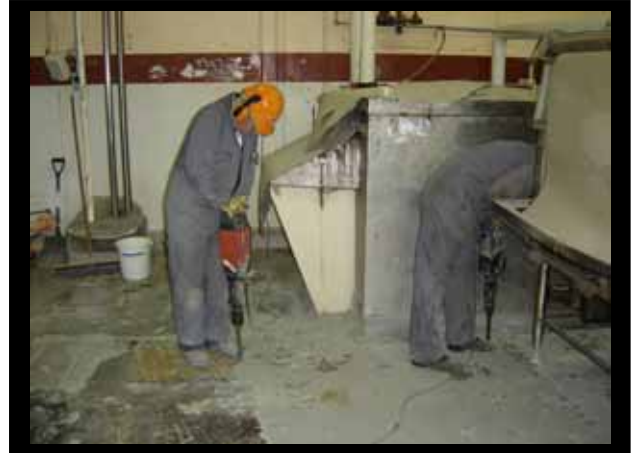
Before...

This factory had a serious safety issue with employees slipping on the existing flooring due to the floor becoming coated with a fine layer of chocolate dust during shifts. Management chose Rhino Linings Pedestrian Access Flooring System to resolve the OH& S issue.

The steel mezzanine floor and a heavy forklift area were sprayed with Duraspray and an aggregate topcoat providing a seamless, durable lining with slip resistant properties.
