QAF Meat Industries- Piggery

Project: Corrosion Protection

Category: Commercial Linings

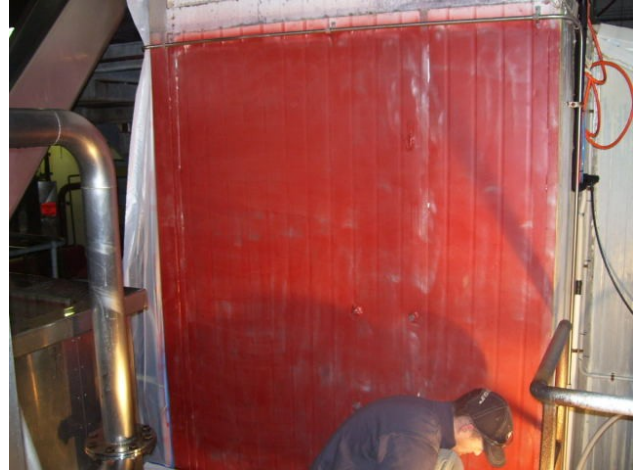
BEFORE

The Corowa based Piggery is one of the largest in the southern hemisphere. Continual wash down procedures for food safety identified the early onset of corrosion in some production areas.

Once identified, these areas were isolated, ground back to the original substrate and primed with RhinoPrime 251 and RL315.
