## CASE STUDY:

### RV and Trailer Roof Repair

**Project:** Repair and rejuvenate aged roofs of recreational vehicles.

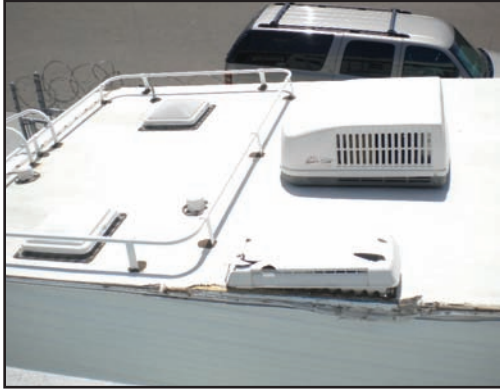
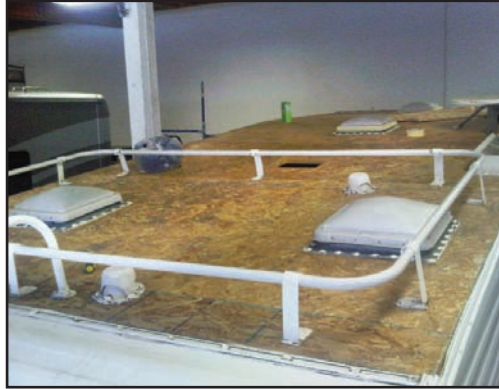
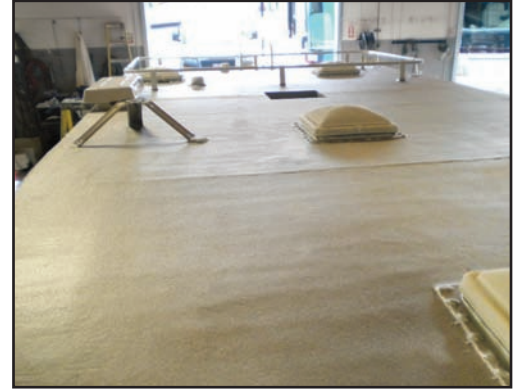
Every month, private owners come to San Diego RV Center with leaking rubber and fiberglass roofs. Traditional repair materials like Dicor rubber or sheet plastics require renewed UV protection every two years and generally fail or have an undesirable appearance within eight years.

In the production process, the existing and failing rubber roof of the vehicle is stripped down to the existing plywood roof. Seams and large gaps are then filled while any previous adhesives on the wood are removed and sanded down. After all the wood is sanded, the entire area is primed with Rhino® 161 primer and then sprayed with Rhino Eco-Coat at varied thicknesses from 1/16" to 1/8" (1.5 – 3.0 mm) depending on area. The new monolithic polyurea coating forms a tight seal around all the protrusions, gaps and bolts preventing water leakage. The desirable silver aluminum like finish improves energy efficiency and prevents degradation due to UV sunlight.
