## TOILET BLOCK

**Project:** Toilet Block Roof

**Category:** Waterproofing

**System:** Rhino Linings TUFF STUFF

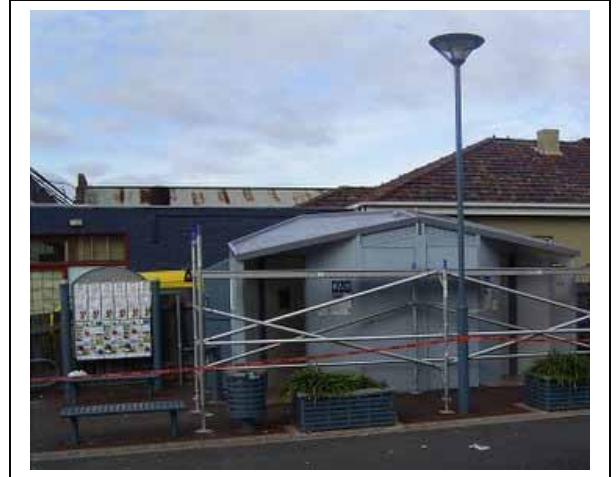
Before...

This public toilet facility was suffering from a leaky roof. The roof was constructed from fibre sheeting and was subject to thermal expansion and contraction making many traditional sealing products unviable.

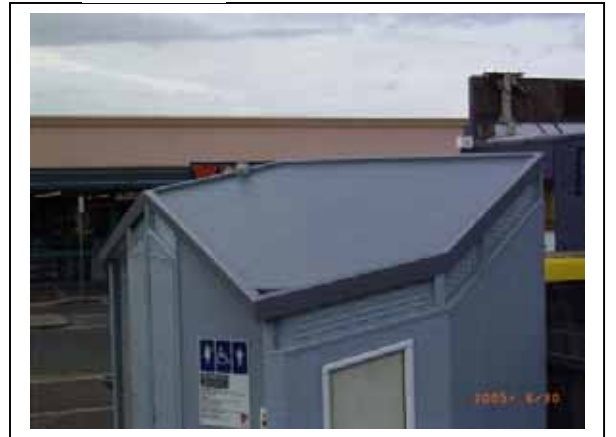
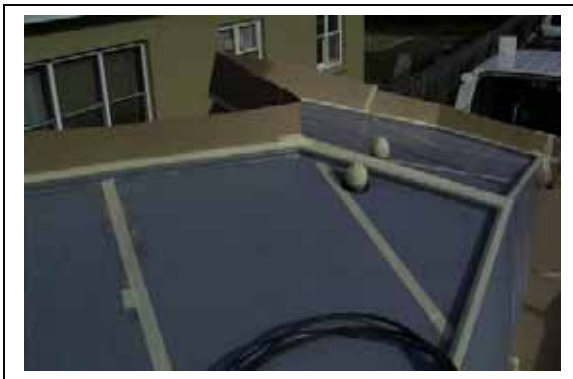
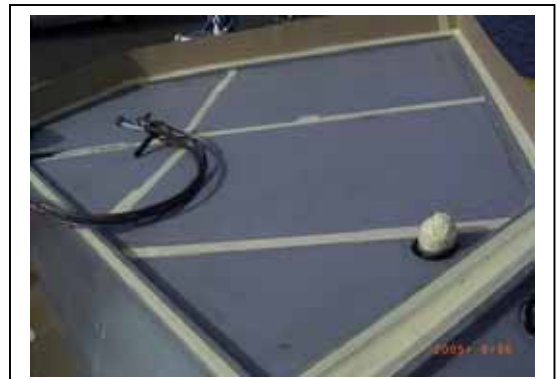
After...

Rhino Linings TUFF STUFF provided the solution. Being spray applied it conformed to the substrate, sealed intricate joins and overlays, cured instantly and is flexible and strong.
