Internal Gutters

Project: High Rise Guttering Problems

Category: Water Proofing

System: Rhino Linings TUFF STUFF

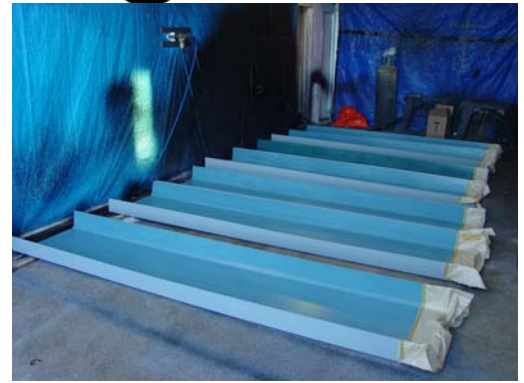
Before Coating ...

This was the result on ongoing problems on a high rise building that had leaks for years. The guttering was originally coated with Butynol and had been patched over and over with no success. New gutters were formed and coated with TUFF STUFF off site, fitted and the gutter seams then recoated with TUFF STUFF – no more leaking gutters.

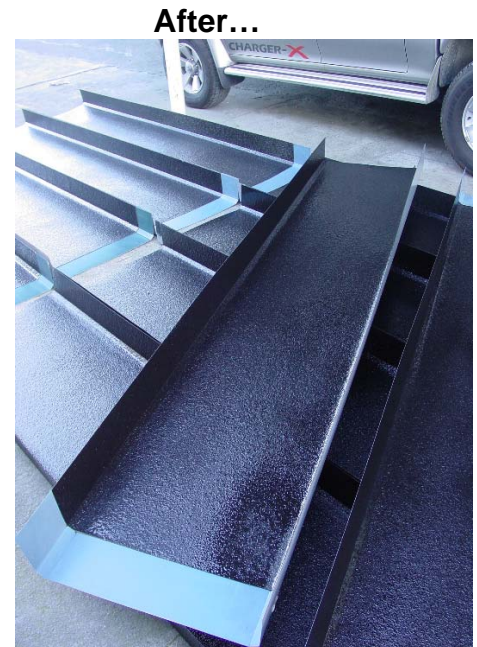
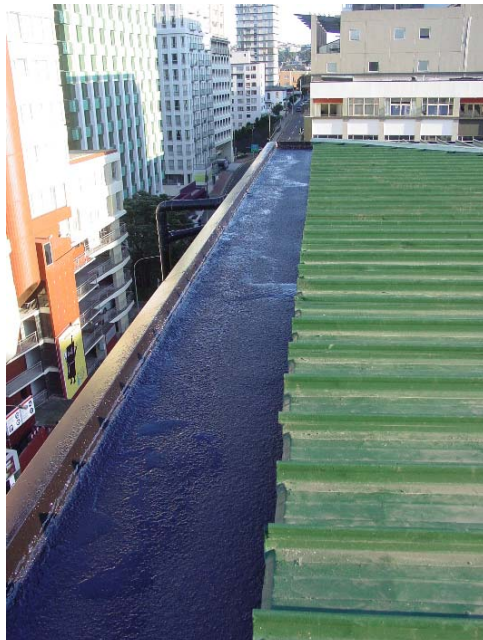
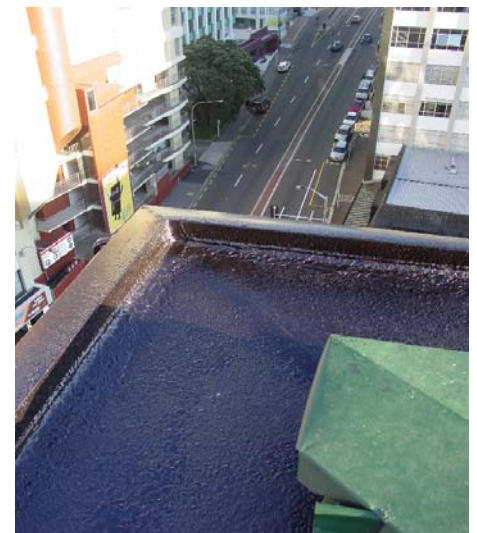
After...
